Ross Island Harmful Algal Bloom (HAB) Design Project

*Clients: City of Portland Oregon and
Ross Island Sand and Gravel*

Bee 446/546: River Engineering, OSU
June 14, 2019

Design Team 8

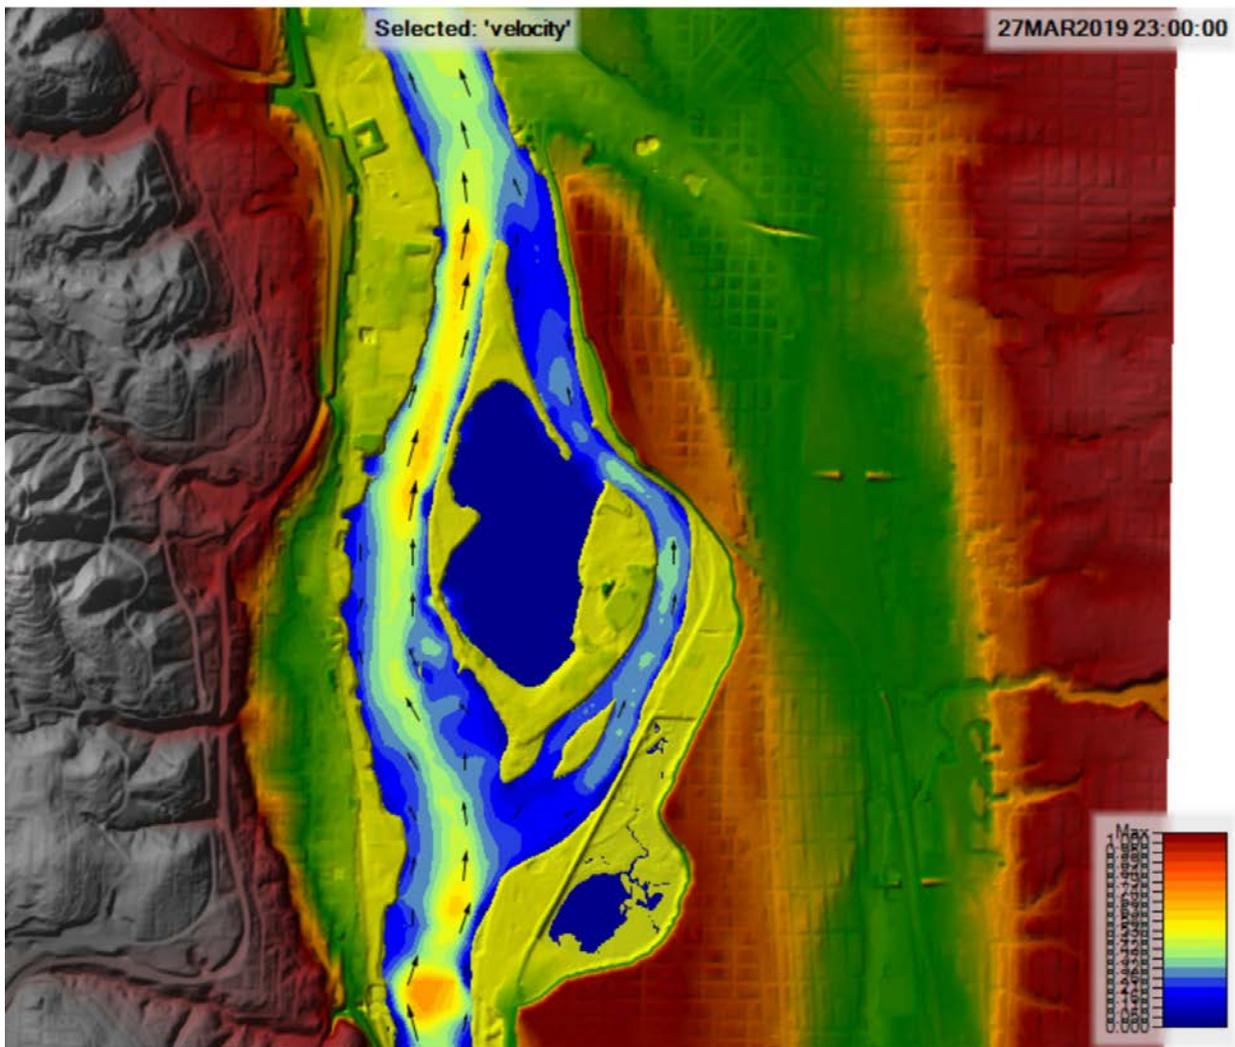
Figure A.1: 2D HEC-RAS modeled velocity results of the Ross Island lagoon.

Ross Island's existing conditions were modeled within a HEC-RAS 2D Model. Results concluded that the tide has significant effects on the ability of the water to mix and flow easily through the lagoon. This process is due to the backwater process that pushes water back into the lagoon at its entrance, minimizing mixing that is necessary in preventing stratification. Due to the low flows seen in the lagoon, it can be assumed that stratification is surely present, and that lack of mixing is present due to the deep depth of the lagoon. Figure A.1 and A.2 of the Appendix display the 2D HEC-RAS aerial results of the varying velocities and depths of the lagoon, respectively. These results confirm the hypothesis of why HAB blooms are present during the low flow season within the lagoon.

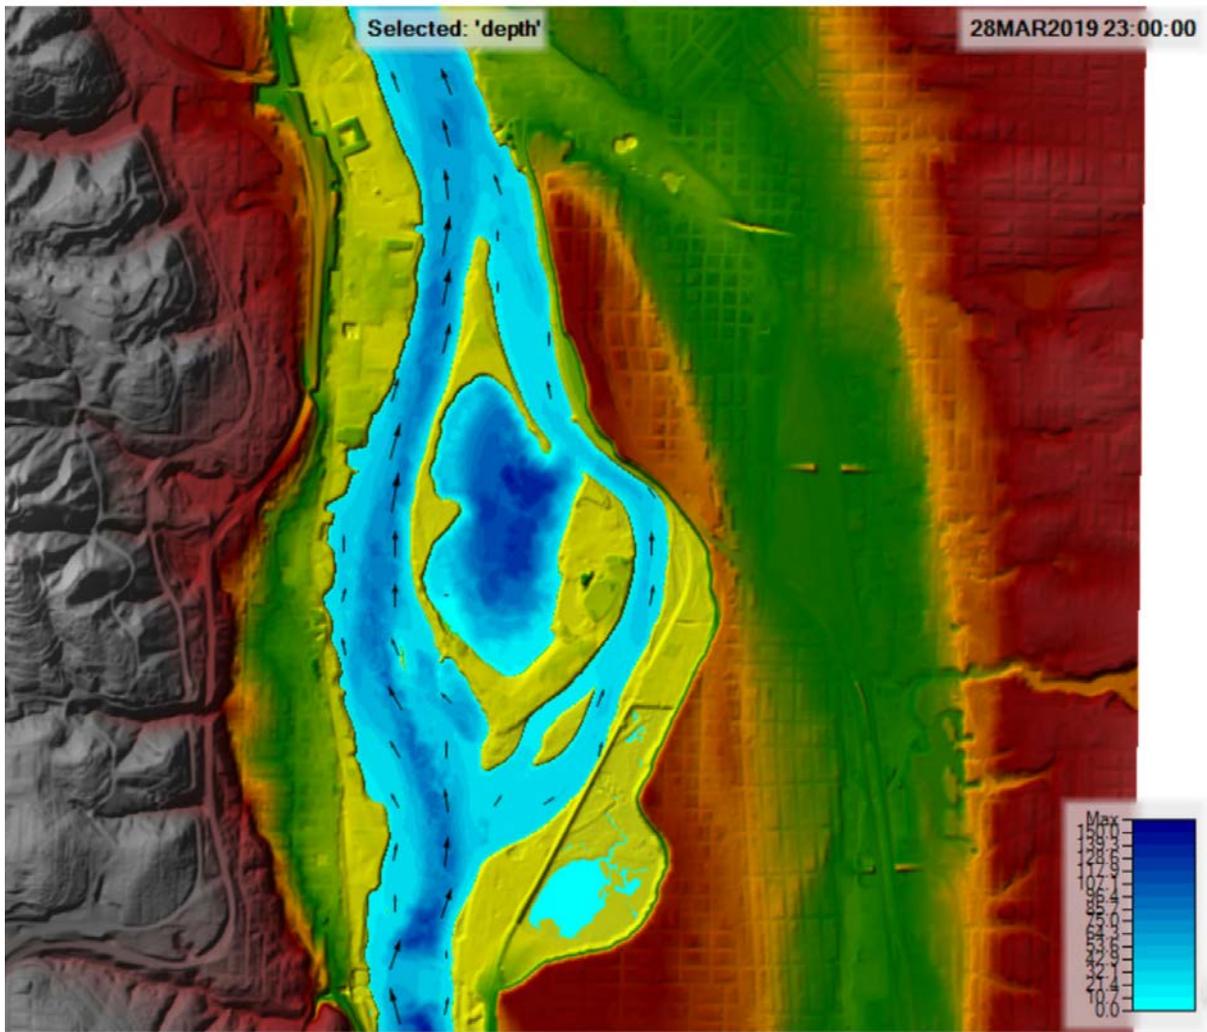
Figure A.2: 2D HEC-RAS modeled depth results of the Ross Island lagoon.

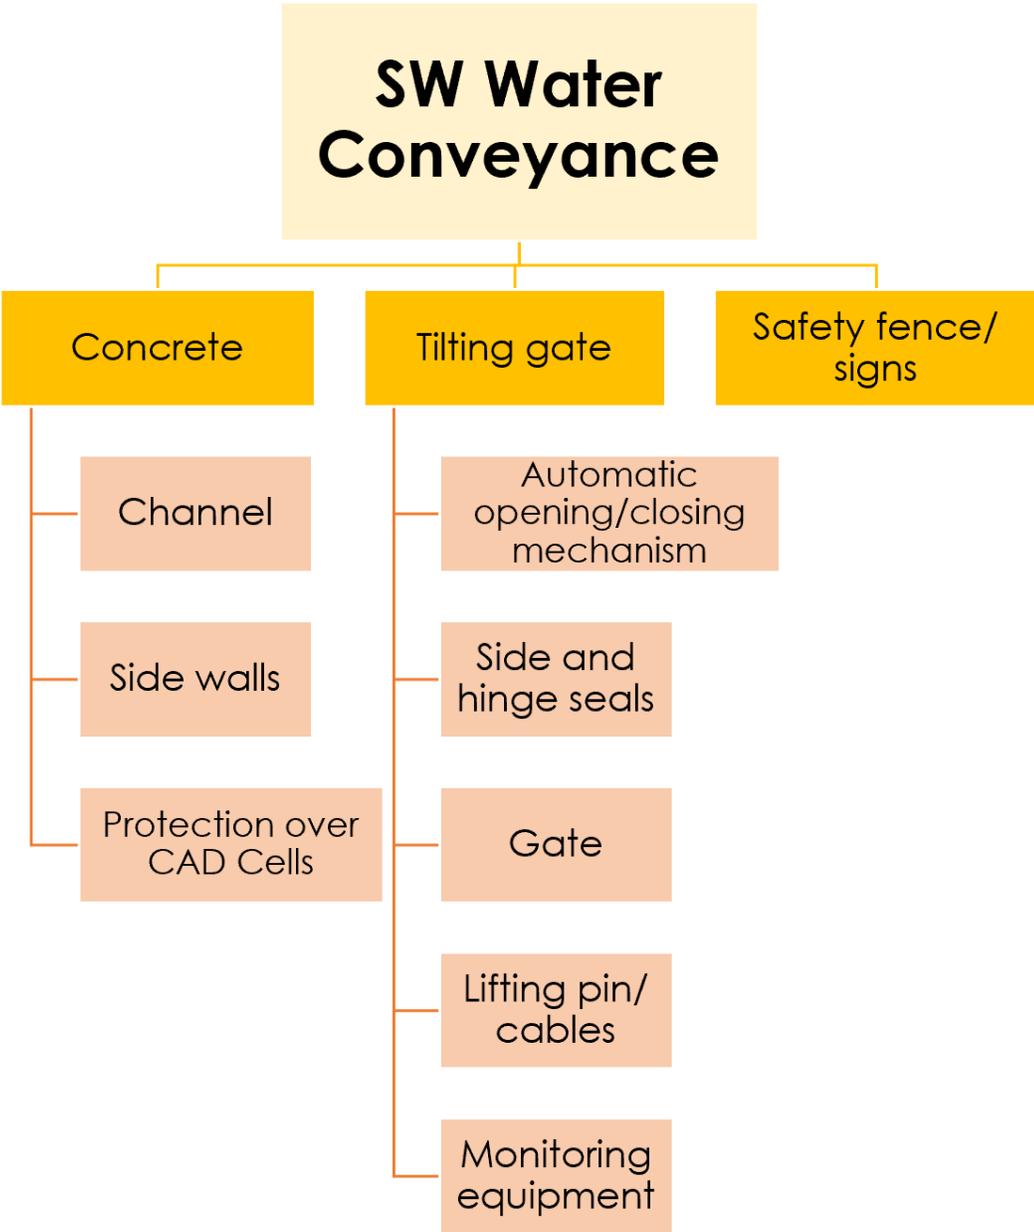
Figure B.1: Hydraulic alternative (southwest water conveyance) functional tree diagram, displaying design features.

Using the functional design tree (Figure B.1), a PFMA was performed for this alternative. The PFMA analysis, shown in Figure B.9, concluded that the failure of closing the lagoon during high flows (whether due to mechanical or human error) resulted in the highest RPN value (RPN of 15). This failure has the highest severity due to the potential impacts of the lagoon capturing the river, resulting in threatening the protection of the CAD cells, habitat, and navigability. A loss of navigability through the lagoon can greatly impact the operation for Ross Island Sand and Gravel (RISG), resulting in the highest severity ranking due to the potential economic loss. Additionally, failure related to the sealing of the channel and gate, as well as debris blockage, resulted in the next high RPN value of 12.

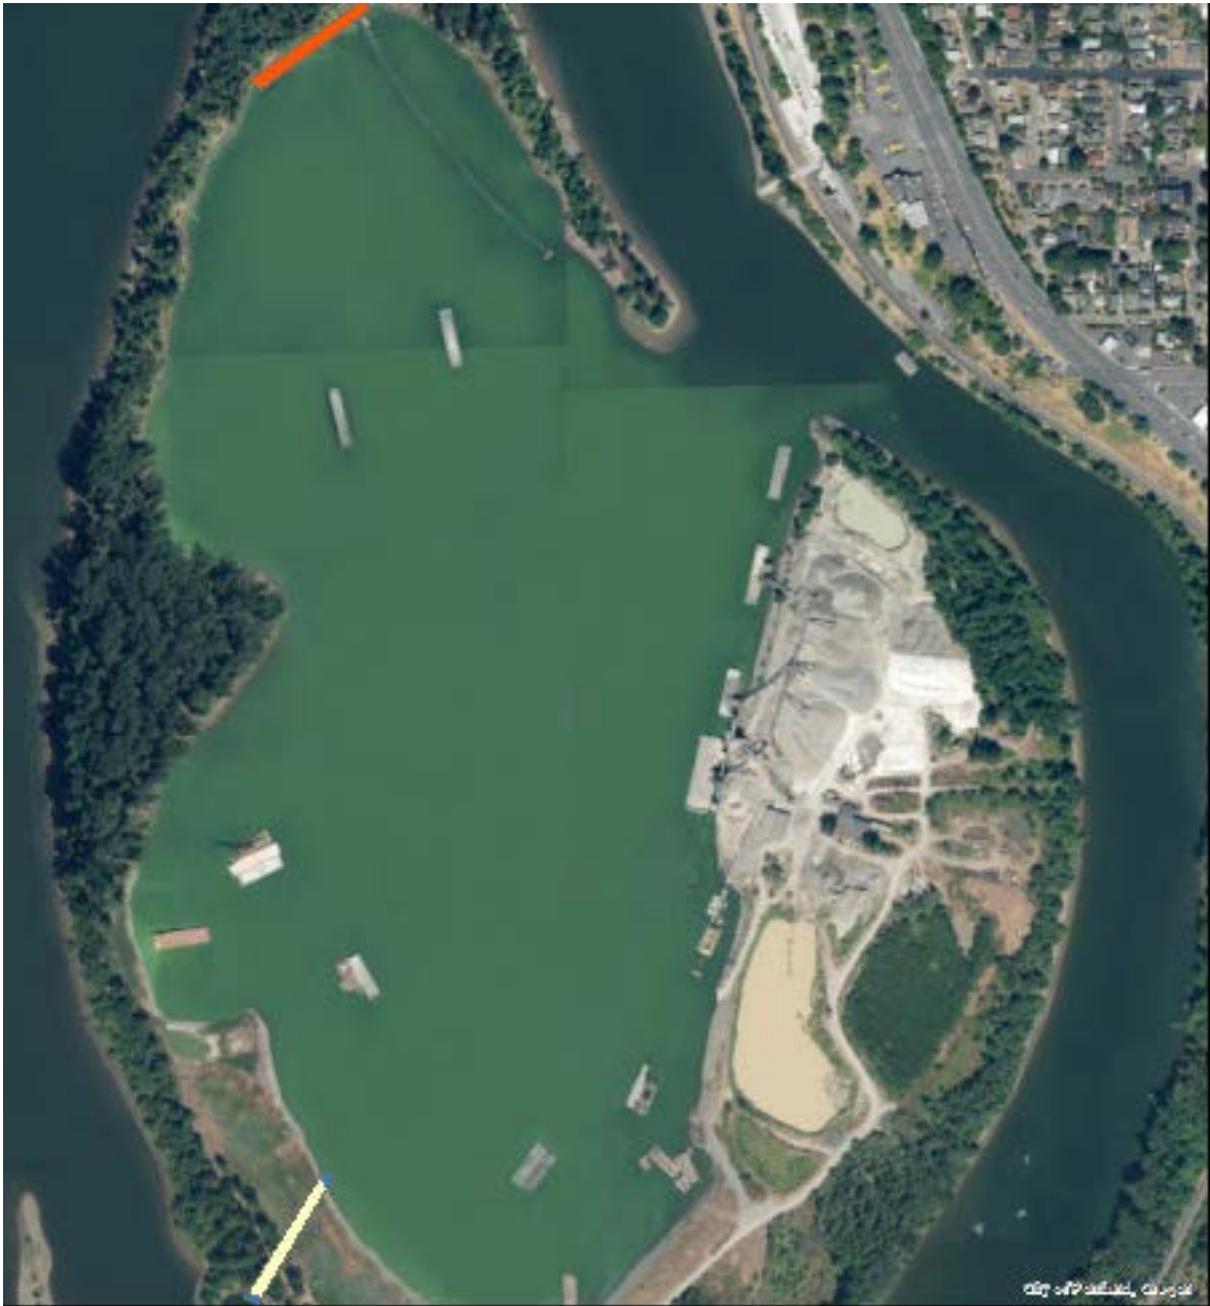
Figure B.2: Map of proposed surface channel location in the SW portion of the lagoon; impacted shallow water habitat and location of replaced habitat is also shown.

Assuming shallow water habitat is defined as 20 feet or less of water, the amount of shallow water habitat predicted to be threatened by the hydraulic alternative is approximately 0.08 acres (estimated using GIS). Figure B.2 displays the representation of this impacted habitat with the overlying channel area. Additionally, 7.8 acre-ft (341,740 ft³) of land habitat is predicted to be impacted by the excavation of the channel (GIS results shown in Figure B.4). This excavated

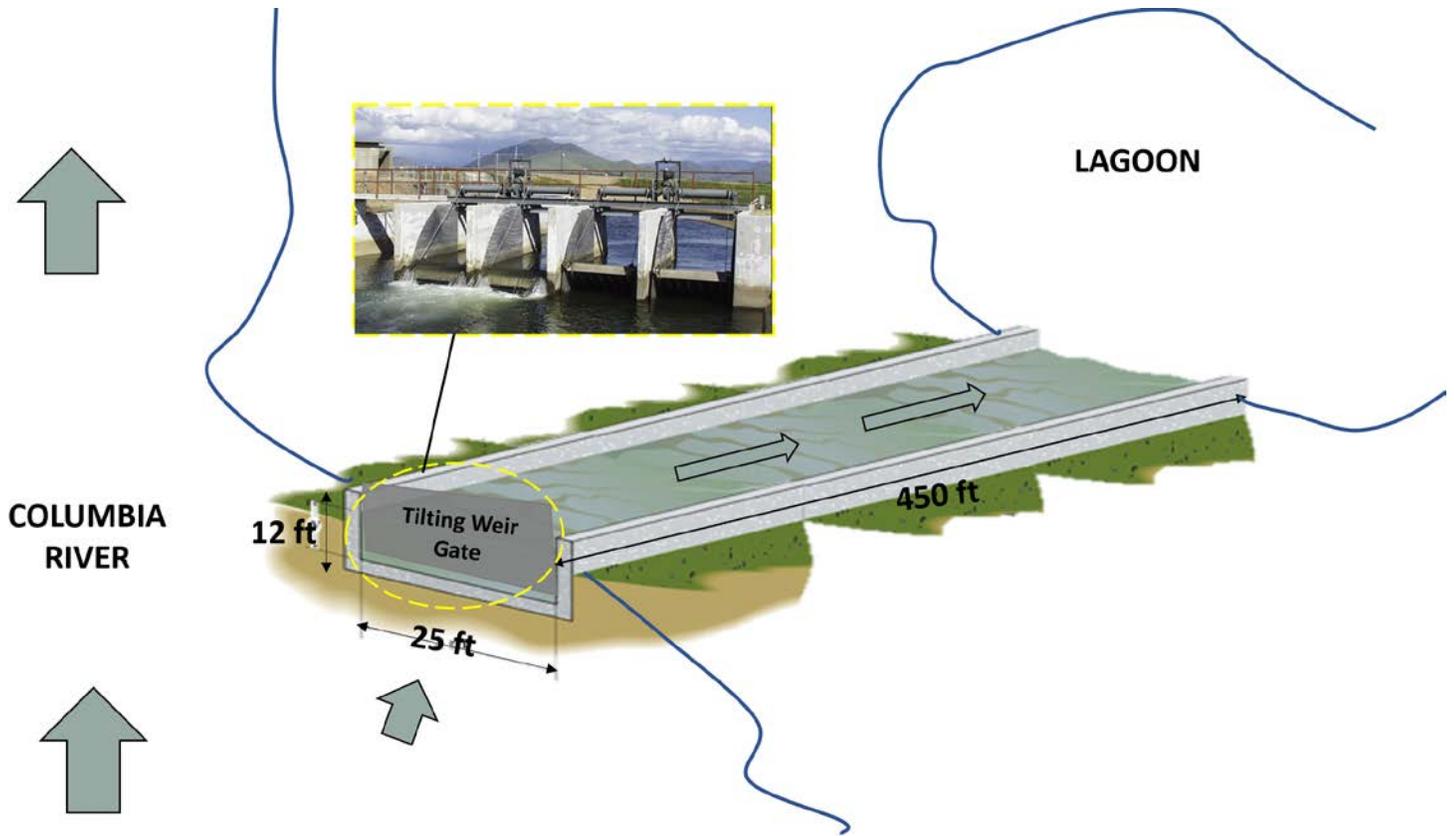
Figure B.3: Conceptual design of hydraulic alternative including a concrete channel within the SW portion of the lagoon, operated using a tilting weir gate at its entrance.

The hydraulic alternative for the Ross Island project involves excavating a concrete channel with a tilting weir gate within the southwest portion of the lagoon. The goal of this alternative is to redirect flow during the low flow season from the river into the lagoon to increase mixing and breakup the lagoon stratification. With the use of the tilting gate, the flow into the channel can be controlled automatically by an operator. Additional benefits in using a tilting weir gate include simple installation and very little maintenance (Aquatic Control Engineering). The functional design tree diagram, shown in Figure B.1 of the Appendix, also presents additional major design features. The proposed channel design is 450 ft. x 25 ft. x 12 ft., at a proposed location shown in Figure B.2. A conceptual drawing of this design is shown in Figure B.3. The width and depth dimensions were chosen to maximize jet-like flow conditions into the lagoon to enable mixing.

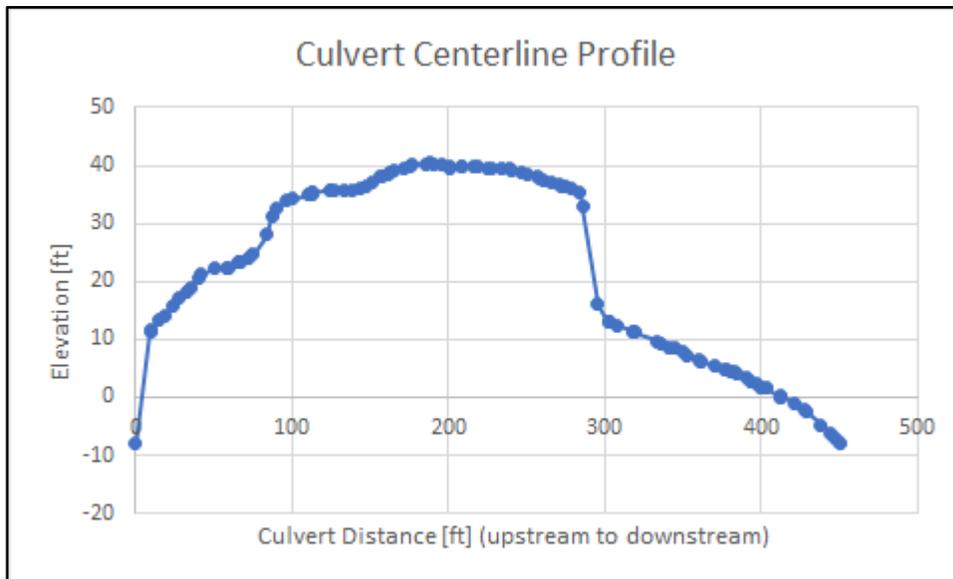
Figure B.4: Station elevation profile of the proposed channel centerline.

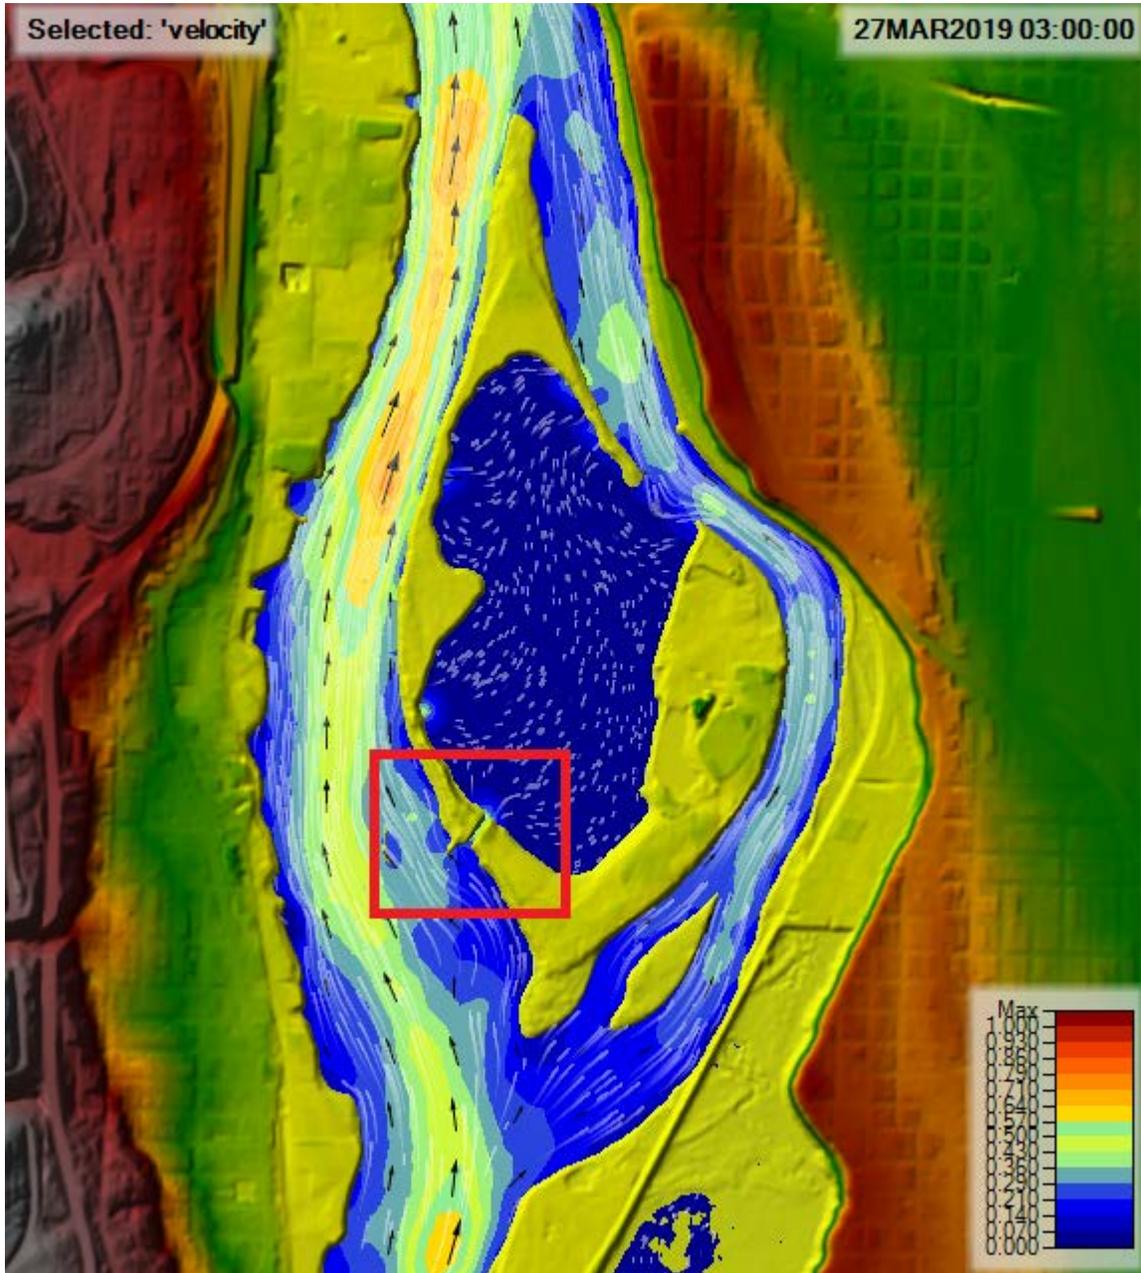
Figure B.5: Proposed condition Ross Island Lagoon Southwest conveyance location and velocity vector model results, full scale.

The HEC- RAS 2D model was used to model to determine the effectiveness of implementing a channel within the SW portion of the lagoon. As previously stated, the goal of this alternative is to create a jet- like flow into the lagoon, increasing mixing and reducing stratification. Effectiveness of the channel can be visually interpreted from observing the modeled velocity vectors, and as presented in Figures B.5 and B.6, this channel design is observed as ineffective. An estimated measurement of velocity vector spreading shows that surface mixing only occurs up to about 300 feet away from the opening of the channel. These results are most likely due to the extreme depths of the lagoon (120+ ft.) and the ability of this depth to quickly absorb all of the forward energy created by the jet. The surface channel design may have more successful results if the channel was deepened or widened, yet doing this will increase excavation and material costs and could potentially draw the main river channel through the lagoon.

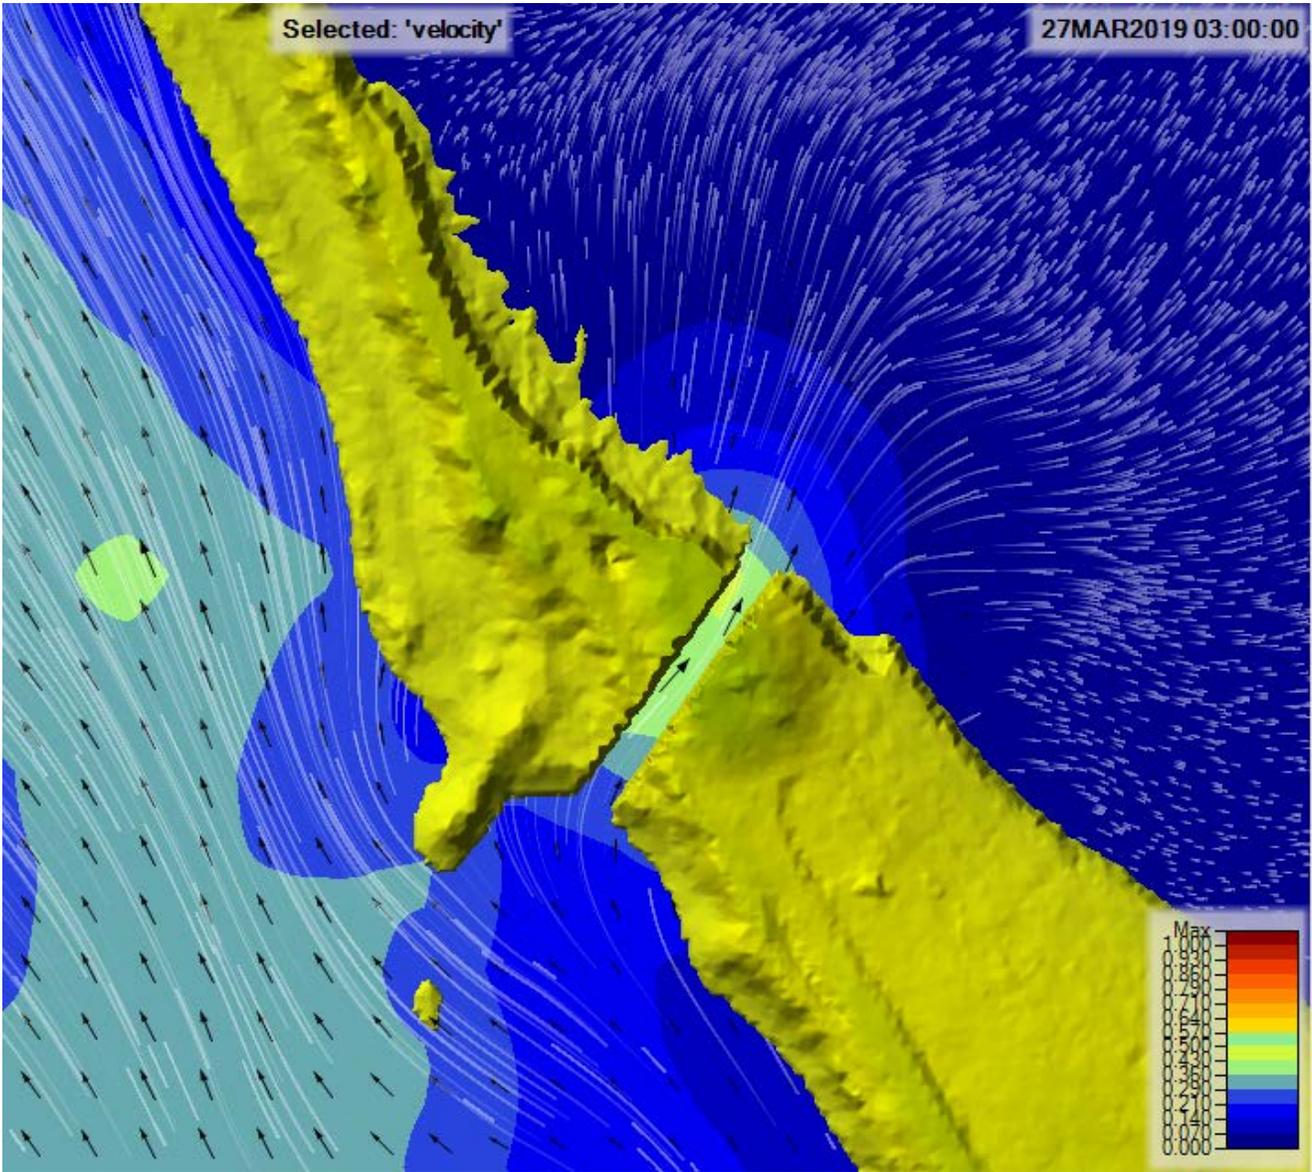
Figure B.6: Ross Island southwest conveyance velocity vector profile, zoomed in.

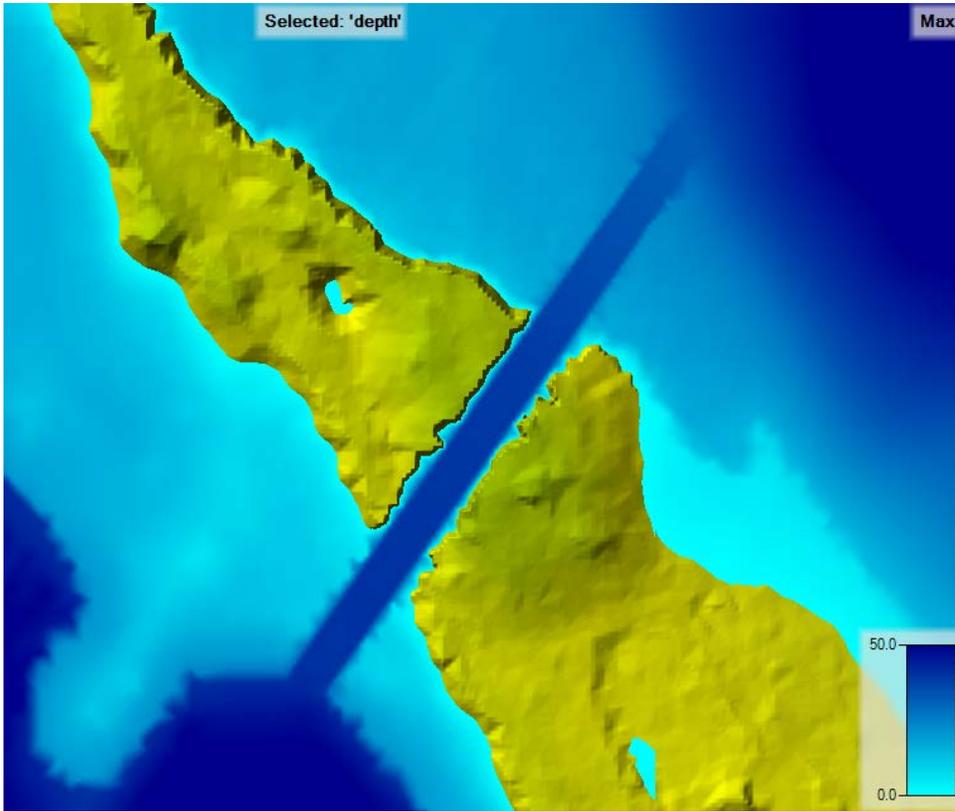
Figure B.7. Water depth for the April Flood event, the highest flow regime.

To determine the durability of our proposed design against various flow events, flow data from USGS for August, December, and April was entered into the HEC-RAS 2D model proposed condition. The model was unable to be fully successfully calibrated. Velocity values were extremely fast, but the water depths appeared slightly more accurate. April had the highest water surface elevation (Figure B.7), and therefore, the highest shear forces to cause bank erosion. The shear forces for the lagoon's regular regime are so low that they can usually be considered inconsequential, but they become relevant as the discharge increases. The sidewalls for our design are high (40ft - Ross Datum) and steep, which keeps our design from being fully submerged and swept downstream, however, the increased shear stress would increase erosive forces and could lead to structural instabilities and increased sedimentation. Exposure of the dangerous CAD cells due to erosion is also of high concern. This only seems to be the case with the April flow event, both the December and August (lowest flow - Figure B.8) events have relatively manageable water surface rise in terms of the proposed channel.

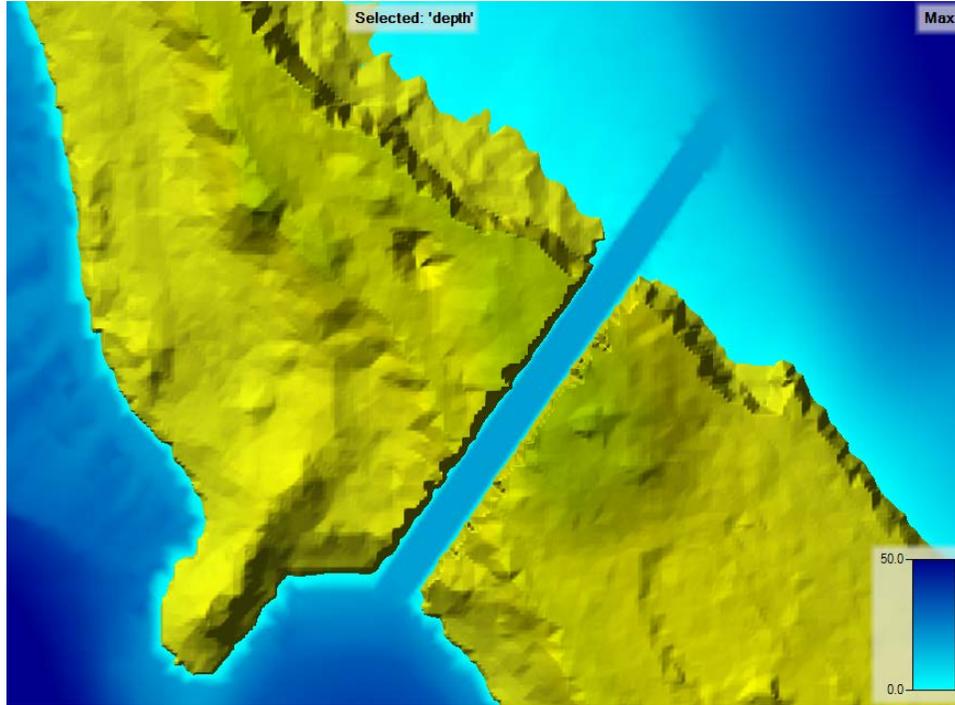
Figure B.8. Water depth for the August flow event, the lowest flow regime.

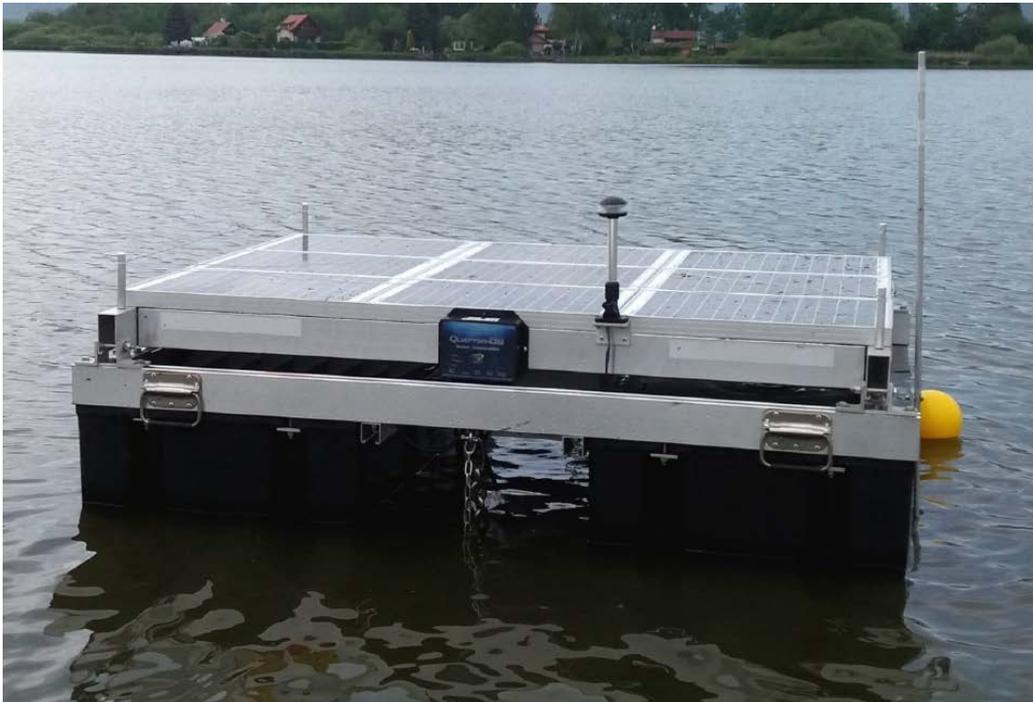
Figure C.1: Photograph of solar- powered ultrasonic pontoon system, provided by SonicSolutions.

The non- hydraulic solution for the Ross Island project involves the use of solar- powered ultrasonic technology, located on anchored pontoons within the lagoon (shown in Figure C.1 of Appendix). This technology works by sending off ultrasound waves that create a sound layer within the top layer of the water, directly impacting the buoyancy of the algae (LG Sonic, 2017). Algae cells then sink to the bottom and are unable to photosynthesize, eventually dying due to a lack of sunlight (Figure C.2). Though not a well known technology, ultrasound has been recognized as a highly effective blue- green algae removal method within industry, including uses for many drinking water reservoirs and wastewater ponds (Zimba, 2013). The literature contains over 50,000 results on Google Scholar regarding ultrasound technology, though the effectiveness still continues to be researched and further understood.

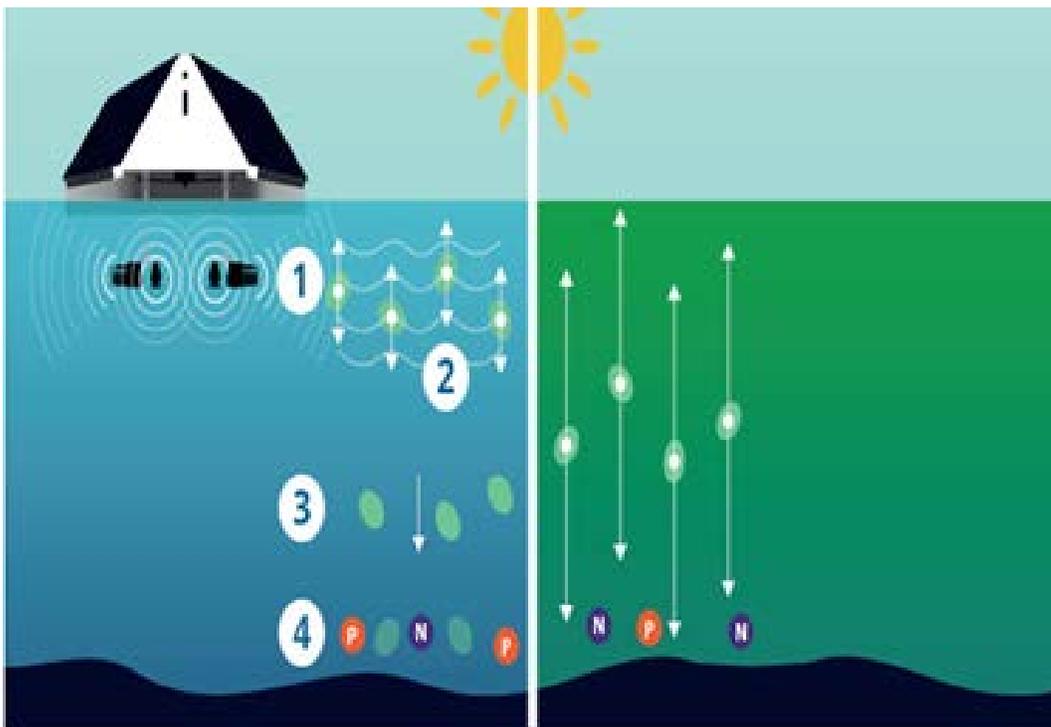
Figure C.2: Schematic of the algae removal method using ultrasonic technology, provided by LG Sonic.

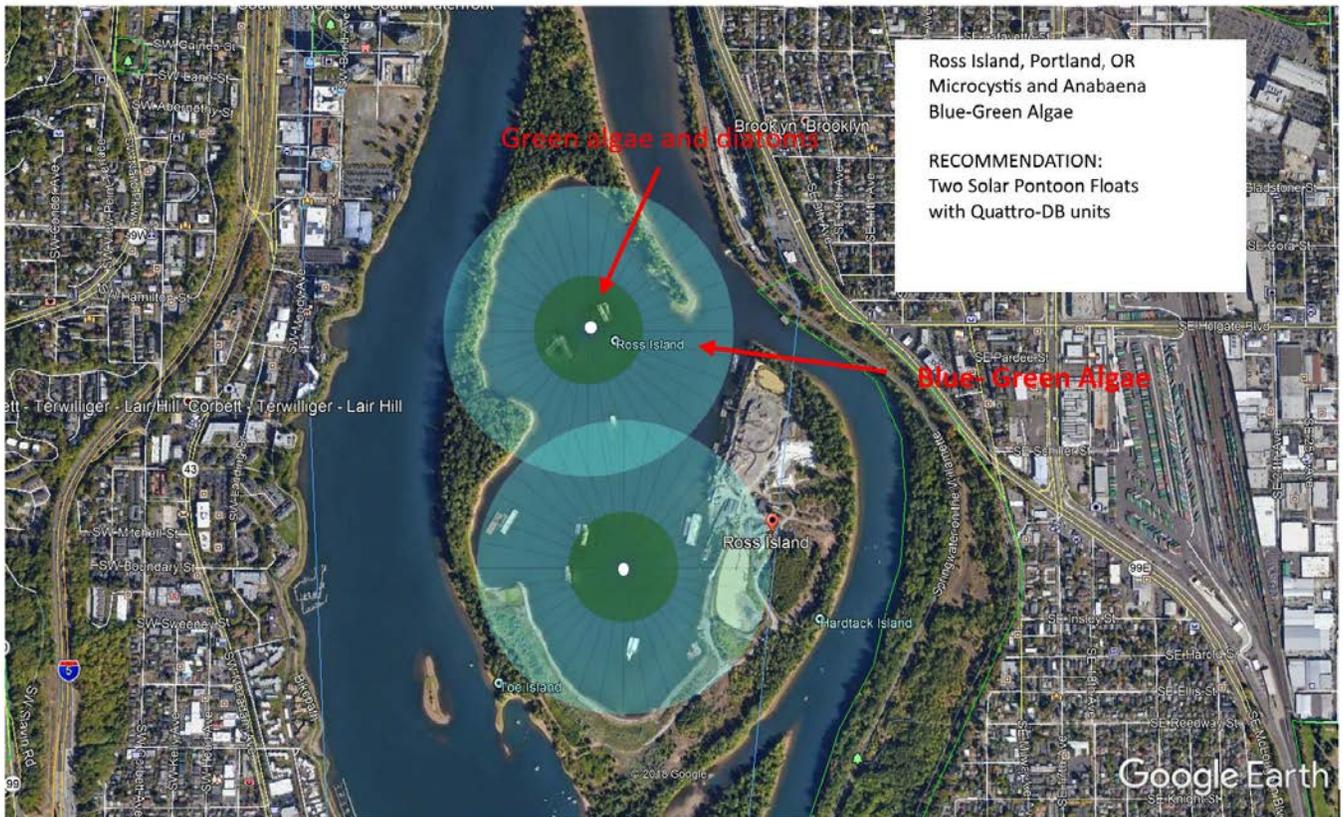
Figure C.3: Google Earth image of the coverage of using two solar pontoon floats with Quattro- DB units, provided by SonicSolutions. The coverage radius for green algae and diatoms are shown in green, and the coverage radius for blue- green algae is shown in blue.

For this project, SonicSolutions LLC was contacted for further specifics regarding ultrasound technology. Following numerous conversations regarding the Ross Island lagoon site, SonicSolutions recommended the use of two solar pontoon floats, each with Quattro- DB units (the ultrasonic transducer). These Quattro- DB units have a 150- meter radial control range of green and diatom algae, and a 400- meter radial control range of blue- green (cyanobacteria) algae, as presented in Figure C.3 for the Ross Island site (Assael and Hutchinson, 2019). As the Quattro- DB transducer is the main working design feature of the ultrasonic system, additional design features include the anchor, pontoon with navigable light and bird deflectors, solar panels, battery box, and a buoy. These design features are also presented in the functional design tree shown in Figure C.4 of the Appendix.

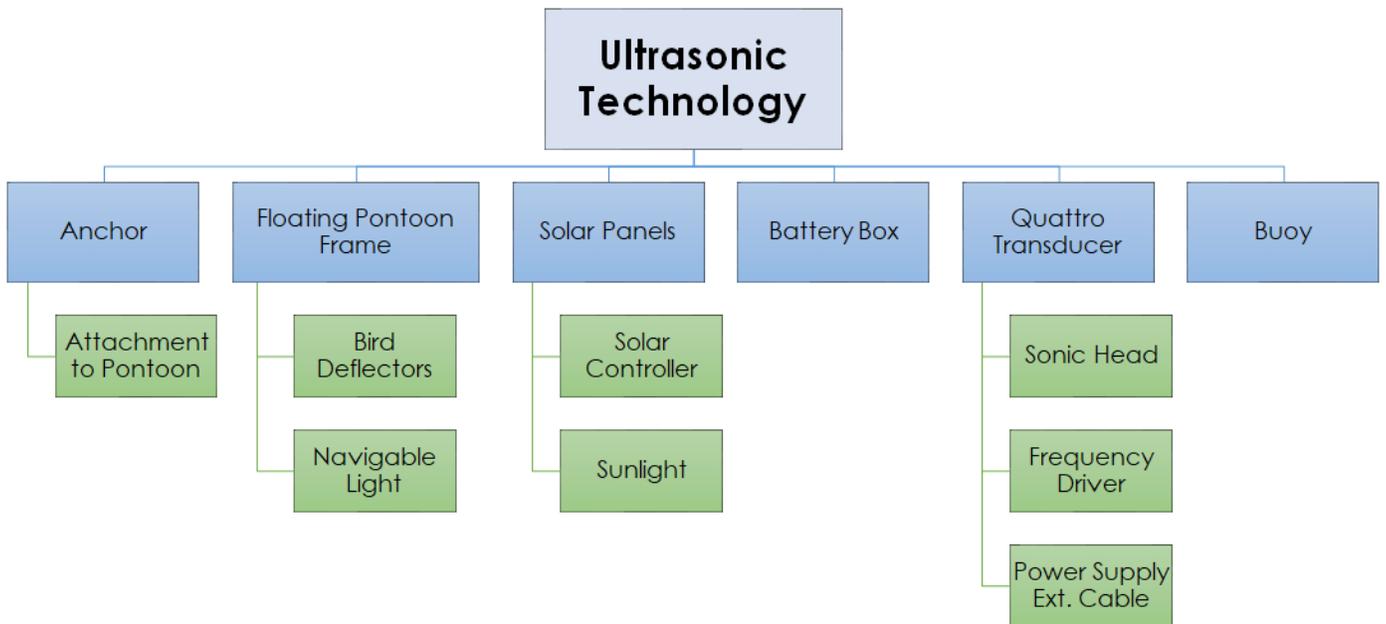
Figure C.4: Non hydraulic alternative (ultrasonic technology) functional tree diagram, displaying design features.

Using the functional design tree (shown in Figure C.4), a PFMA was performed for this alternative. The PFMA analysis, shown in Figure C.8 of the Appendix, concluded that failure modes related to the ultrasonic technology are low, only ranging from 2-4 RPN values. Note, that each of the failure modes had similar severity rankings, with the only difference being within the ability to detect the specific failure. A few of the main failure modes include mechanical failure of the solar panel causing loss of power, mechanical failure of Quattro- DB transducer causing an inability to send ultrasonic waves, and the inability for the ultrasonic waves to effectively remove the HABs. Each of these failures result in an ineffective HAB removal method, leaving sustained blooms within the lagoon.

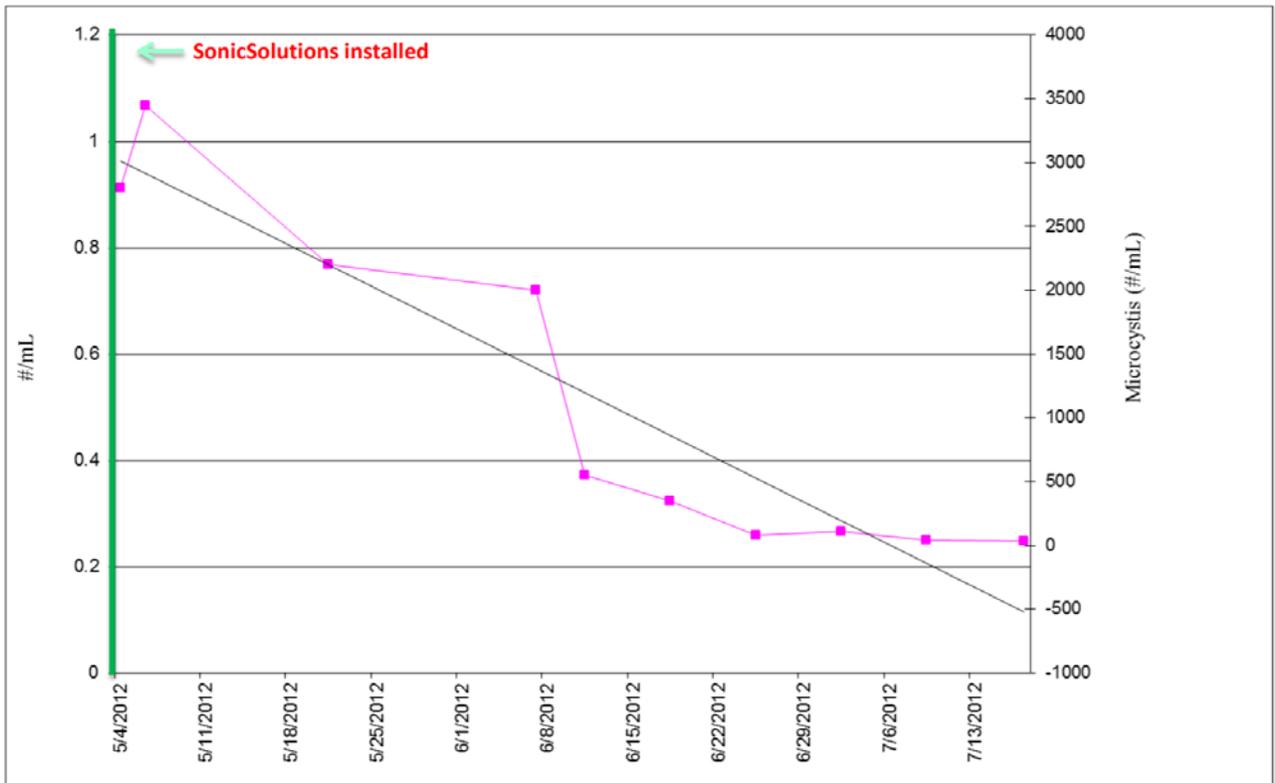
Microcystis cell counts for Lakeview Park Pond in TX during ultrasound treatment (2012)

Evaluation of Sonic Solutions Ultrasound for Control of HABs, Paul V. Zimba, Center for Coastal Studies, Texas A&M University Corpus Christi, Corpus Christi, TX

Figure C.7: Microcystis results for a SonicSolutions case study performed by Paul V. Simba of Texas A&M University Corpus Christi (Zimba, 2013).

Additionally, SonicSolutions expects existing blue/green and/or filamentous algae to be eradicated in a period of 3 to 5 weeks. Though once the water is clear of existing algae, minor additional blooms may be observed as pre- existing algae spores on the bottom of the pond are being warmed by the new direct sunlight. These new minor blooms are expected to be eradicated within 2 weeks. When observing the literature of this topic, Wu et al. and Paerl et al. mention algae eradication between 2-6 months when using ultrasonic methods.
